CITY HALL FEASIBILITY STUDY

City Hall Feasibility Study

RE: Inspection of Council Chambers, Benton City, WA

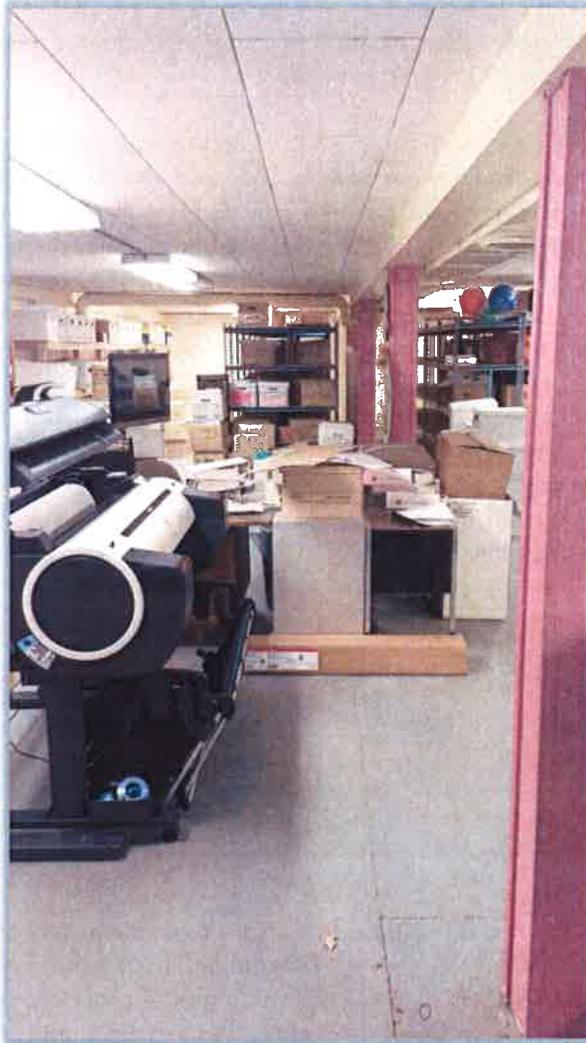
The beam supporting the floor of the existing Council Chambers cannot support the current design load. The design load is approximately 800% of what the current beam can support.

Floor Beam: the floor beam currently has a clearance of 7'-6" from the floor to the bottom of the beam. This is the legal minimum height for an open space in

Figure 1: Record Storage Area with Beam

a building. The most practical option is to remove the existing beam and replace it with a metal beam. In order to have a Council Chambers without the column in the open space is to install two new columns at each end of the room. This will require constructing two new footings below the basement floor.

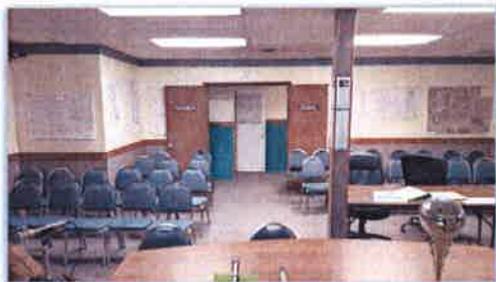
The beam supported by the column in the center of the existing Council Chambers (roof beam) cannot support the current design load. The design load is approximately 300% of what the current beam can support.

Figure 2: At Council’s table looking toward audience. Ceiling beam and floor beam run left to right located above and below column in center of room.

Roof Beam: the roof beam can be upgraded in place by adding to the beam in-place. After discussion with a contractor, the best end product would require the removal and replacement of the false ceiling. Otherwise, there would be broken tiles and bent frames. New tiles and frames in some areas of the ceiling would not match the existing ceiling.

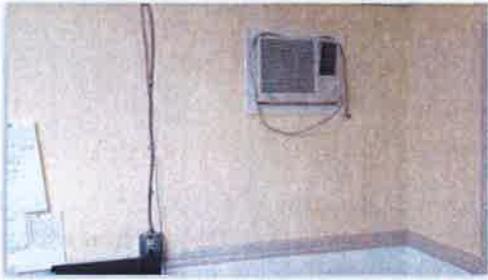
Figure 4: Air Conditioner in current southeast corner office.

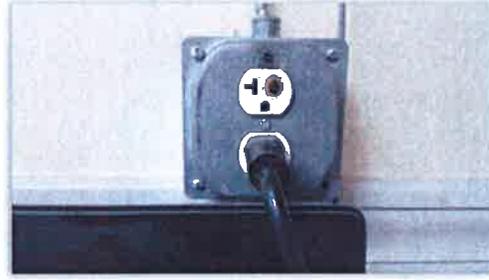
Figure 5: Outlet for Air Conditioner. Re-wiring work is anticipated.

New walls will require new electrical wiring. Labor and Industries indicated that if there were no major changes to the circuits, no new panels would be required. Based on the problem with the southeast corner office, \$20,000 has been added to the cost estimate to cover any cost with required upgrades and repairs. Also included are appliances for the break room, doors, two windows and a vaulted ceiling in the lobby.

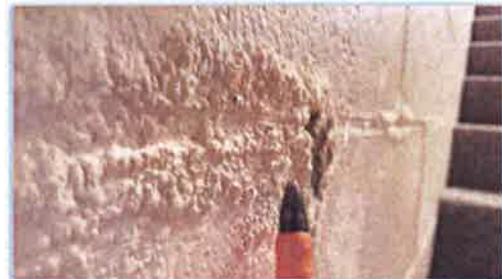
During the building walk-through earlier this year, mold was noticed on the south wall next to the stairway and open area in front of the bathrooms in the basement. Two firms were contacted. One firm said they were not available for approximately one week. All-Safe Abatement came out within a two-day's notice to perform the mold abatement. Water is leaking through the walls from the walkway between City Hall and the building to the south. The work for correcting this issue is included

Figure 6: Mold Abatement, February 2016

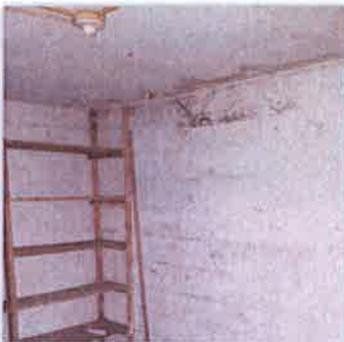
Figure 7: Sheriff's Office

The old Sheriff's Office will need to undergo mold abatement to make this area usable. A cost estimate was received from All-Safe Abatement for this work. The cause of the mold is water leaking through the walls from the sidewalk above. The base of the block wall sits on top of the basement floor. The base blocks need to be drilled and pressure sealed along the west wall, stairs and open area in front of the bathrooms. Additional remediation of the leaks is discussed in Section V: Exterior Work. Additional items needed for the basement upgrade are a video system setup for recording Council meetings, a new platform and Council table, new lighting, and a new HVAC system.

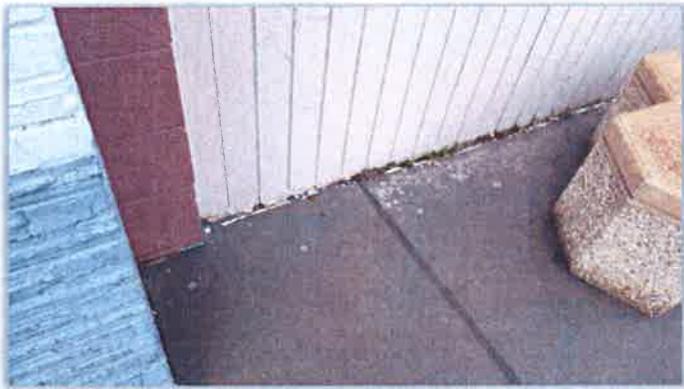
Figure 8: Northwest corner of City Hall

Another area where leaks have been a problem is along the west end of the building. This is due to the construction of the sidewalk up to the building front. The sidewalk was constructed up to and above the siding. At the northwest corner of City Hall, the sidewalk is actually sloped toward the building (picture to left). In 2009, the leaks were addressed with the low cost alternative of putting in a sealant/caulking at the face of the siding. This worked for several years, but was not considered a permanent fix.

A permanent fix would require the removal of the sidewalk between the building front and the street curb and gutter, from the north end of the building to the south end of the building. At a minimum, the siding will need to be removed one foot above the sidewalk. The replacement sidewalk should have a three to four inch curb placed against the building in a monolithic pour. New siding will include flashing that helps direct water over the “building curb” and onto the sidewalk, away from the building.

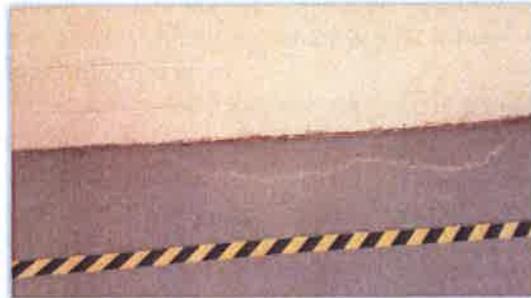
Figure 10: Basement West Wall – Leak Stain

As shown in the pictures above, the caulking job has become ineffective due to weathering and “shrinking” over time. A seal of this type is not considered a permanent fix due to direct exposure to the weather.

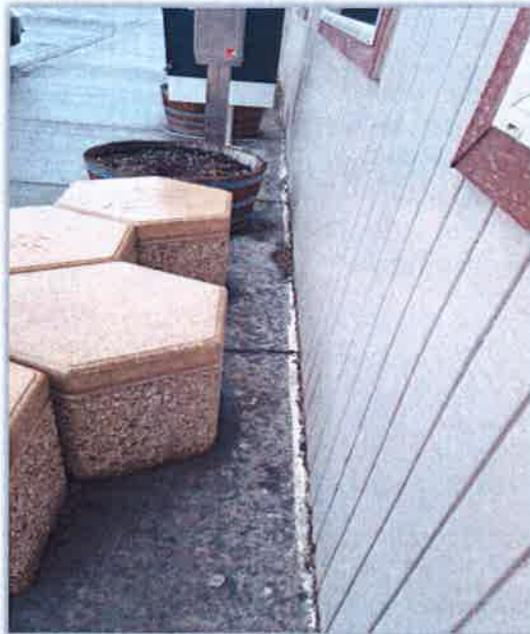
Figure 11: Sidewalk and Building Joint

At left, the joint between the building and sidewalk is shown, looking north from the City Hall front door. The City Hall front wall joins the adjacent mini-mart (blue wall at top of picture). This location has a reverse slope back toward City Hall for approximately 10 feet. Moss is growing on top of the caulking installed in 2009. A permanent fix to the leaking would require the removal of the sidewalk between the building front and the street curb and gutter, from the north end of the building to the south end of the building.

At a minimum, the siding will need to be cut approximately one foot above the sidewalk to allow for the installation of a new sidewalk with a four-inch “curb” to be installed against the building. The sidewalk would be sloped away from the building toward the street and curb. New siding with

flashing would be installed from the cut line to just above the new four-inch curb. Flashing would be installed such that runoff water from the building front would be directed to the new curb and sidewalk, draining away from the building.

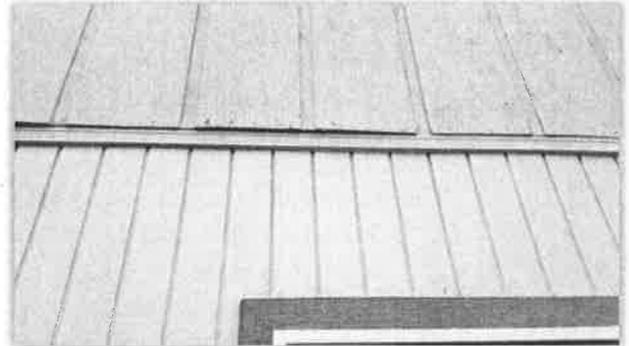
Figure 12 shows the siding on the front of City Hall. The upper section of the siding is warped and coming away from the wall. It was strongly recommended by the contractor reviewing the building, that the siding be replaced to help prevent damage to the interior structure of the wall fascia. A cost for this work is included in the cost estimate.

Figure 12: City Hall Front Wall Siding
