CITY HALL FEASIBILITY STUDY

City Hall Feasibility Study

RE: Inspection of Council Chambers, Benton City, WA

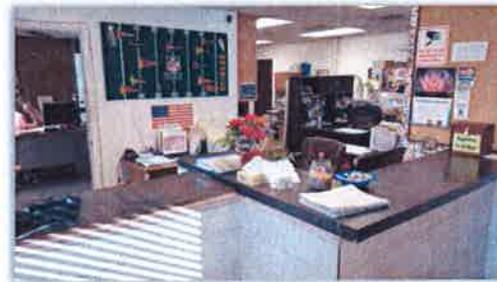
Figure 3: At front desk/public reception area. Receptionist site behind counter on right. Counter space on right and left is used to assist residents & visitors.

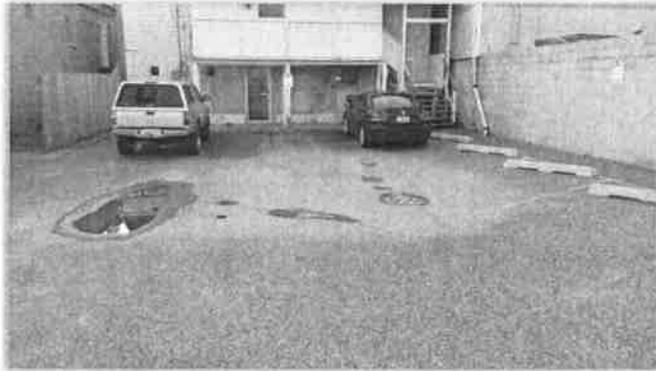
If the Council Chambers is moved downstairs, there will need to be ADA parking on the lower level to allow for access to the new Council Chambers. The Building Department was consulted on the possibility of using the back parking lot for temporary ADA parking during the Council Meetings and revert back to employee parking during the day. The Building Department said the parking spaces would need to be established as ADA parking on a permanent basis. This would require employees to park on the street side of City Hall. At the current time there are three employees at City Hall who park in the back. They would be required to park on 9th Street and take up street parking for patrons of City Hall and downtown businesses.

Figure 13: Parking in back of City Hall
